**10TH INTERNATIONAL
MULTIDISCIPLINARY SCIENTIFIC
GEOCONFERENCE
S G E M 2 0 1 0**

FLOODS AND FLASHFLOODS IN EDIRNE (TURKEY)

ABSTRACT

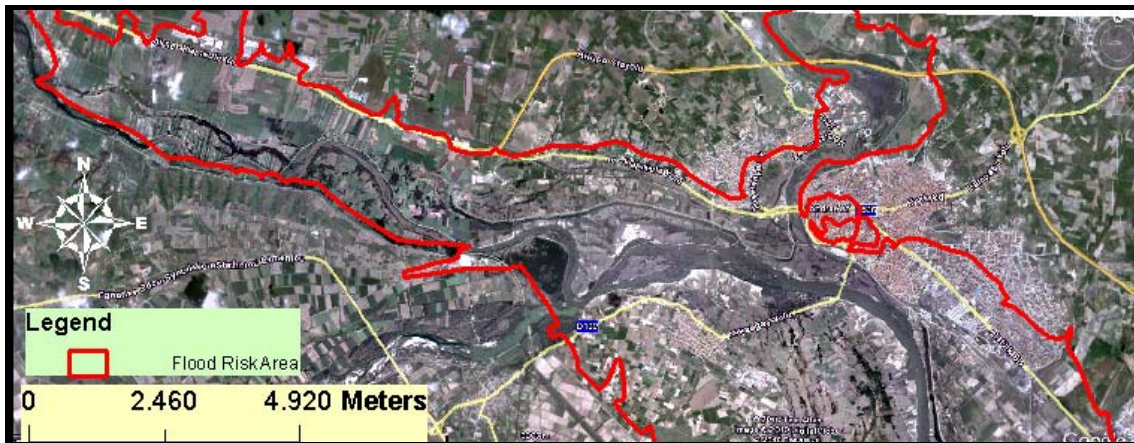
Figure 6: The flood risk areas in Edirne city center.
