IBAC 2012

Conference Proceeding Book, Vol.2

**FROM PAST TO PRESENT: FLOODING IN EDIRNE AND ITS VICINITY
(TURKEY)**

Hüseyin TÜROĞLU & Musa ULUDAĞ

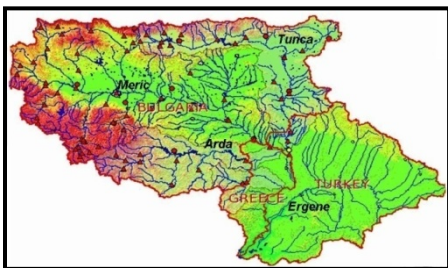
Figure 1: Meriç River Basin (Sezen, 2011).

The floods causing great destructions in Edirne take place as a result of Meriç River's increasing to exceptional flows in the region of Edirne. Meriç River with a large part in Bulgaria, placed within the borders of Greece and Turkey is basically formed of four big sub-basins. (Figure 1, 2). Although the floods occurred in Edirne are natural results of geographical developments in these sub basins, only the area where flood disaster occurred was focused on in this study. (Figure 3). In this part of Meriç Basin; where the old city of Edirne was placed on the surface of the plateau, Meriç River flood plain and the slopes setting these two geomorphologic units apart are land forms that come into prominence. (Figure 3, 4, 5). The surface of the plateau is with a 100-140 metres height is split by the branches of Meriç River. The flood plain of Meriç River is at 42-32 metres height in the part of Edirne. 42 metres height in northwest decreases to 32 metres in the direction of southeast within a distance of 25 km. (Figure 4, 5). When these height values are taken into account, it is obviously seen that Meriç River has an approximately 0.4% incline in the area of the flood plain within the part of Edirne. This incline value is quite appropriate for the flood and is an encouraging feature. The drainage system of Meriç River in the part of Edirne is also in the quality of encouraging flood. Meriç River, Tunca and Arda meet at the alluvial plain with 0.4% incline in only the 6 km distance (Figure 3, 4, 5, 6). These drainage systems cause water mass with great volumes able to result in a flood accumulate in one place. In other words, the water Meriç, Tunca and Arda Rivers bring, gather in the alluvial plain of the basin at the same time. The present drainage channels are not capable to carry such a volume of

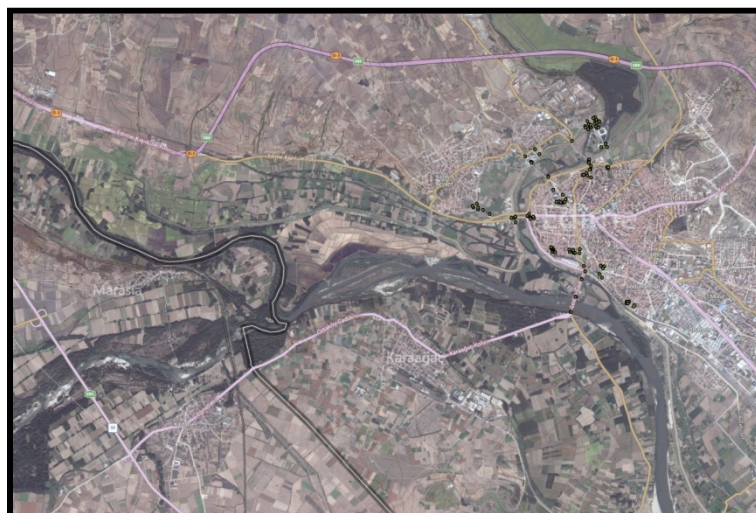
Figure 3: Connections of Meriç, Tunca and Arda Rivers in Edirne region.

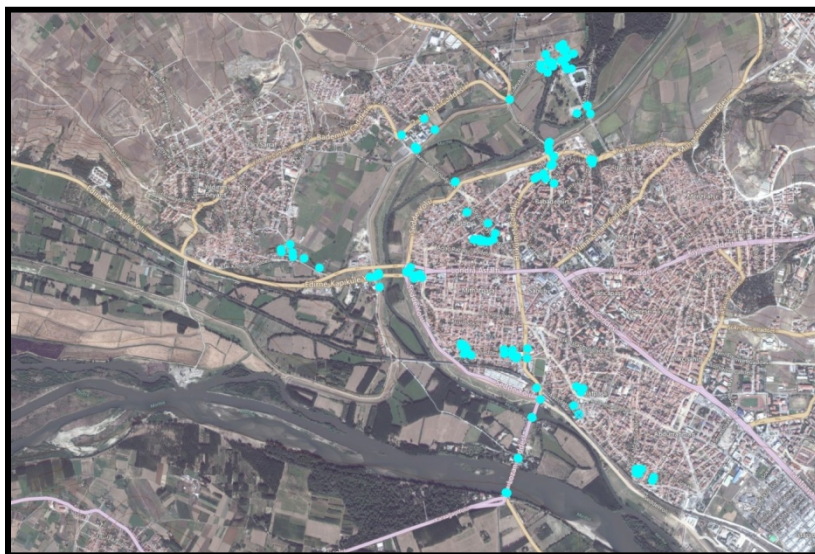
Figure 7: Locations of old buildings damaged from floods during the Ottoman period.

It is stated in the archive records that because of the old floods Ottoman period Edirne's large areas and nearby villages submerged and even as a result of floods in 16th, 17th and 18th centuries, Edirne and some villages got stuck because of the flood and the citizens there suffered from famine for days. It covers a lot of space on archive records that Ottoman Period floods stroke cultivated areas strongly. In general; another feature of the floods occurred in 16th, 17th and 18th centuries is their being at very low frequency however longer floods (Figure 7) (Photo 1, 2).

The location of damage information acquired after archive review and the Ottoman buildings remained from flooded areas were mapped (Figure 7). When the kind, strength and the location of the damages caused by old floods are investigated, it is possible to reach meaningful results for present. The most important factor on this topic is that; the flood reality which can also be named as disaster always exists but the frequency of it is so little.

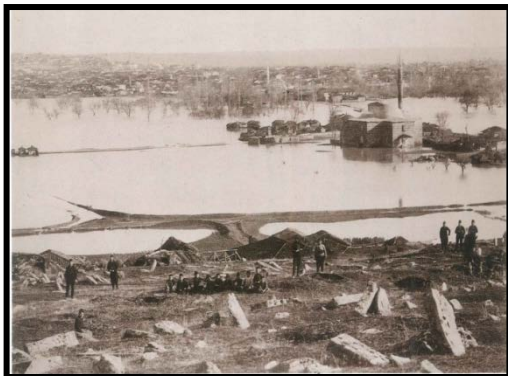
Photo 1: Tunca flood in December 1894.
