# PRESENT STATUS OF STURGEON IN THE LOWER SAKARYA RIVER IN TURKEY

Memiş, D., Tosun, D.D., Yamaner, G., Tunçelli, G., Gessner, J. (2019). Present status of sturgeon in the lower Sakarya river in Turkey. *Aquatic Research*, 2(2), 53-60. <https://doi.org/10.3153/AR19007>

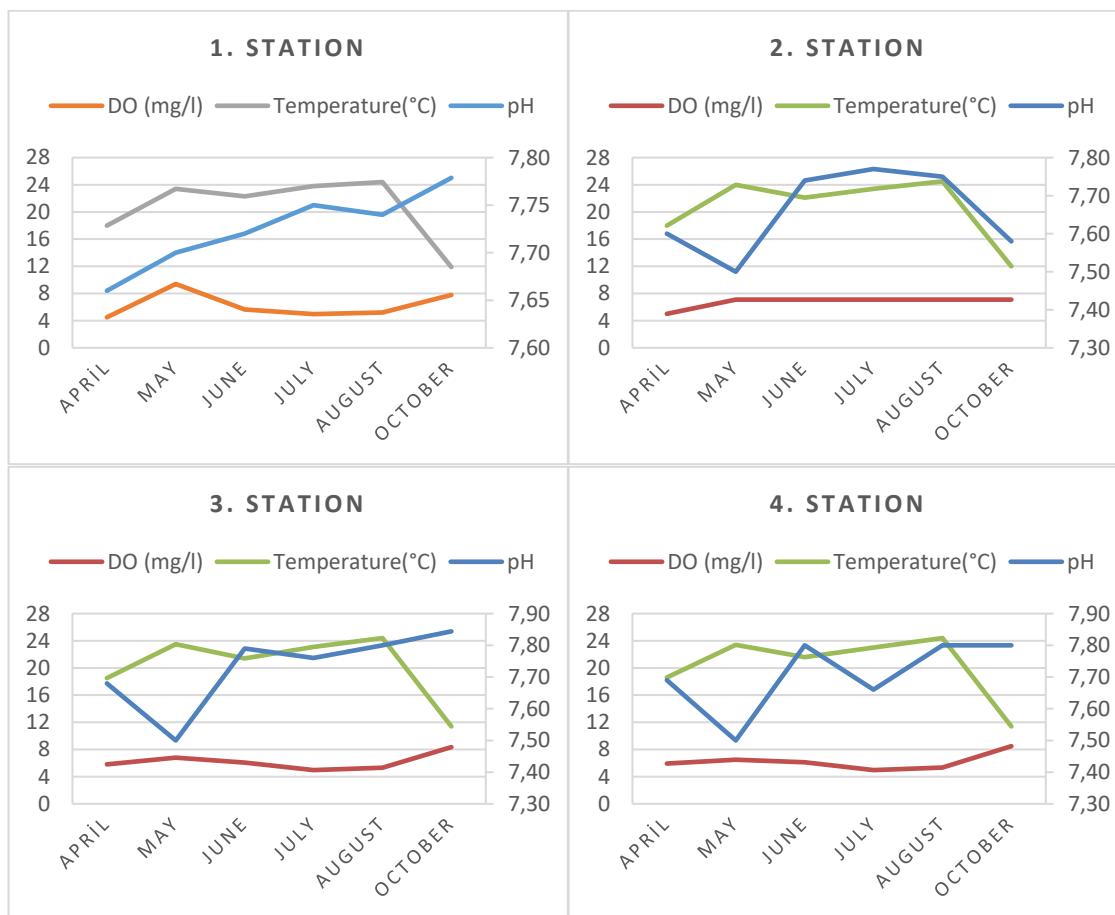
**Figure 2.** Water quality parameters (temperature (°C), dissolved oxygen (mg/L), pH) during the stations throughout the study.

The water quality (temperature, dissolved oxygen, and pH), transparency and depth at the sampling points in the Lower Sakarya River revealed that water temperature, dissolved oxygen and pH levels were similar between the four stations. There were no significant differences between water quality parameters of the sampling stations ( $p > 0.05$ ). Water temperature showed an average of  $22.6 \pm 0.99^\circ\text{C}$  between May and August and showed a marked decrease after August. The pH values reveal a stable level at around  $7.7 \pm 0.1$  but their development shows marked differences with larger fluctuations in the first 3 months of the sampling period in the upper three stations while the lower river values are rather stable. The oxygen contents at all 4 stations are low with an average of  $4 \pm 1.16 \text{ mg/l}$  (Figure 2). At mean water temperatures of  $22.6^\circ\text{C}$ , this reflects saturation levels of 50-55% indicating massive oxygen consumption through sewage and nutrient discharge.
